Manhole Inspection Summary

Manhole # **S41KK_063MH**

Insp Date: **9/8/09 11:27 AM**

Location Address: **1702 BOND ST**

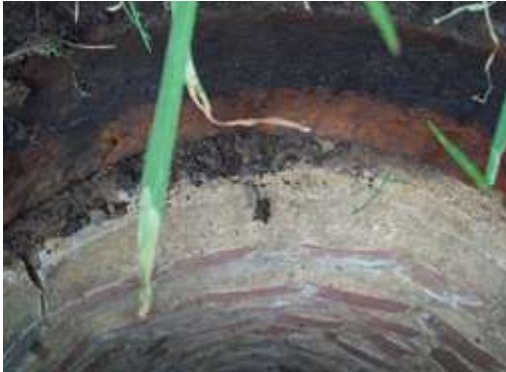
Defect 1

Frame Offset: **1** (in.) Condition: ☒ Sound ☐ Cracked ☐ Leaks

FRAME OFFSET

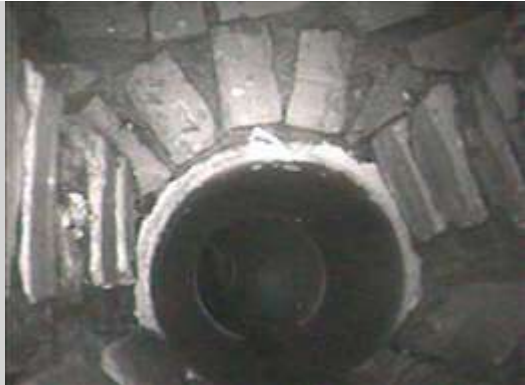
12 O'Clock Outflow

8 in. Circular Gravity Sewer
Pipe Out @ 12 O'Clock

Pipe Height: (in.) Direct
Pipe Material: **Clay** ☐ Pipe Lined
Invert Depth: **17.90** (ft.) Flow Characteristics: **Slow**
Deposits: ☒ None ☐ Mud ☐ Sludge ☐ Debris ☐ Grease
Silt Depth: (in.) Deposits Extent:
Infiltration: **None** Pipe Seal Cond: **Sound**

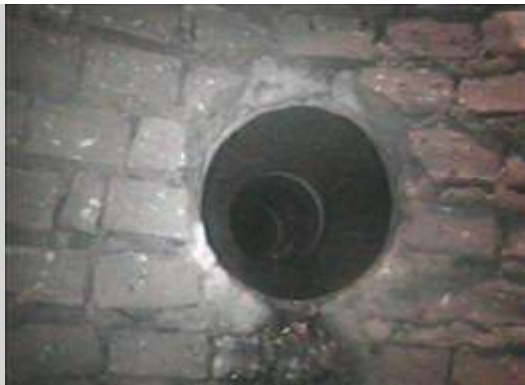
6 O'Clock Inflow

8 in. Circular Gravity Sewer
Pipe In @ 6 O'Clock

Pipe Height: (in.) Direct
Pipe Material: **Clay** ☐ Pipe Lined
Invert Depth: **9.00** (ft.) Flow Characteristics: **Slow**
Deposits: ☒ None ☐ Mud ☐ Sludge ☐ Debris ☐ Grease
Silt Depth: (in.) Deposits Extent:
Infiltration: **None** Pipe Seal Cond: **Sound**

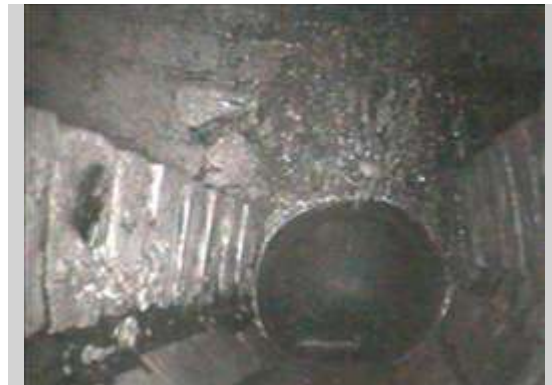
Drop In @ 6 O'Clock

Drop: **Inside** **Direct**
Angled: Reading: (ft.)
Inv Depth: **17.00** (ft.)
Drop Condition: **Open**
